Docket No. 217 – Development and Management Plan Inspection

Norwalk Substation

Date: March 23, 2006

Plumtree Substation

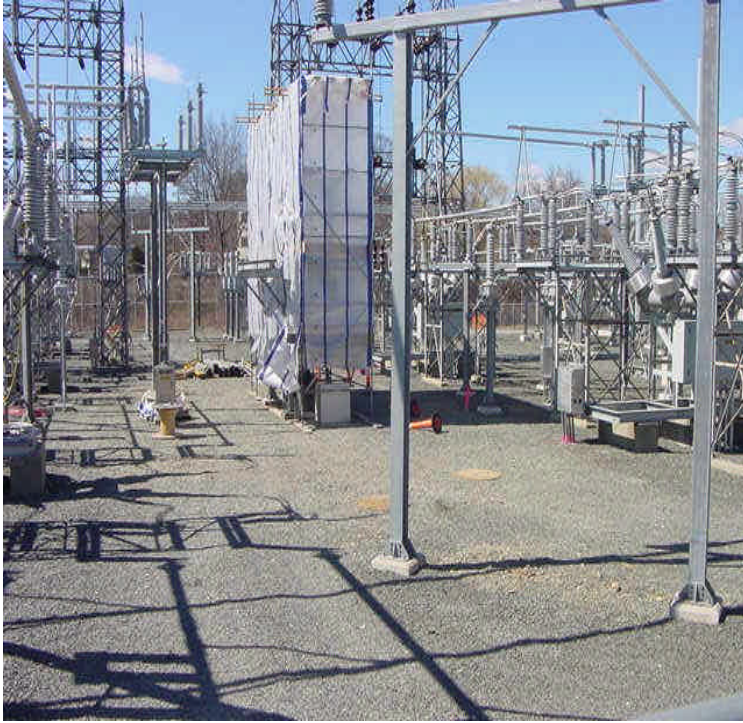
- Some work continues within the live yard. 3/15-3/23/06.	- None at this time. Work remains controlled. 3/23/06.	-N/A.
Erosion and Sediment Controls	- Sediment accumulation continues in the stone onsite at one of the access gates. This is a result of offsite stormwater and roadway sand 1/4-3/23/06.	-None at this time. 3/23/06.	-N/A

Norwalk Substation: Photo on the left shows work continuing within the live yard. Photo on the right shows a general overview of the yard near the GIS building with most materials removed and cleaned up. 3/23/06.

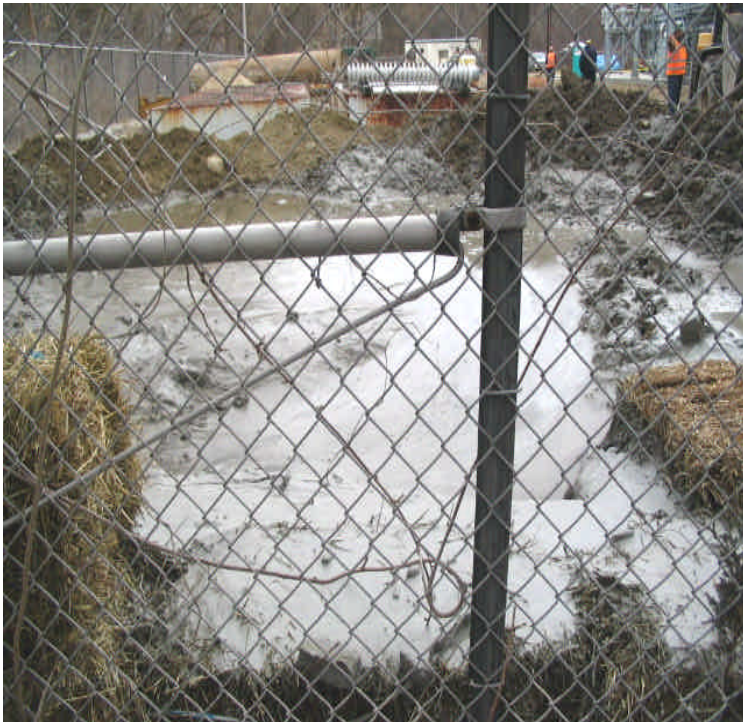
Areas of Inspection	Observation	Recommended Action	Corrected Action
	this equipment. 3/15-3/24/06		
Foundation construction	<p>- Work continues within the substation yard with some significant excavation and caisson drilling. 3/15-3/24/06.</p> <p>- Active caisson drilling was occurring at the time of inspection. 3/24/06</p>	<p>- Remain aware of the perimeter of the yard and the workspace and the fact the area is surrounded by wetlands. 3/15-3/24/06</p> <p>- See erosion control section. 3/15/06</p>	- N/A at this time.
Erosion and Sediment Controls (includes inspection within 24 hours of a storm event)	<p>- Haybales were installed adjacent to the stockpiles by the perimeter stone berm. 3/24/06.</p> <p>- A haybale basin was installed at the fence corner to hold drill cuttings, water and stone dust from the caisson drilling. Sediment spilled over or seeped through the bales and tracked into the adjacent wetland. 3/24/06</p>	<p>- Continue to monitor that the controls are effective. 3/24/06.</p> <p>- The capacity of the basin will need to be increased and we discussed installing a plastic liner to contain the muds. The sediment will also have to be removed carefully from the wetland ASAP. 3/24/06.</p>	- Haybales were installed here.

Plumtree Substation: Photo on the right shows a basin installed to handle drill cuttings, stone dust and water from the caisson drilling. Photo on the left shows where materials seeped out or overflowed the basin from the yard. 3/24/06

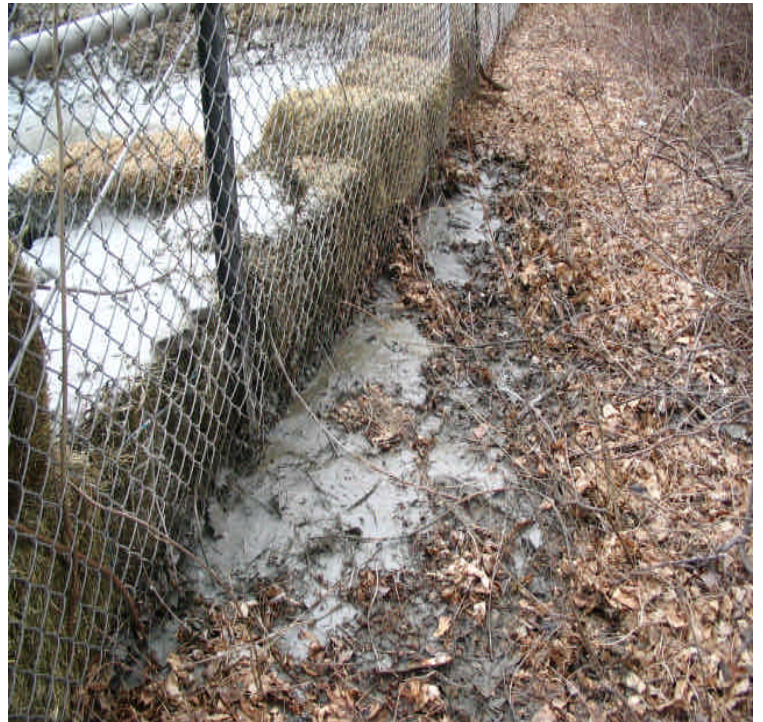
Areas of Inspection	Observation	Recommended Action	Corrected Action
Dewatering	- Dewatering or removal of stone dust from the caisson hole was being sent to a basin on site which is not currently large enough to handle all the material. 3/24/06.	- See the erosion control section for details. 3/24/06.	
Blasting	- No blasting is occurring on site at this time.	- None at this time.	-N/A
Spills and Material Storage	- No spills or leaks were noted. Now that machinery has returned, continue to monitor. 3/24/06	- The contractors should remain vigilant about securing and handling fuel containers. - Keep all vehicles maintained well (i.e. no apparent fluid leaks) if they will be used or stored on site. Check equipment status on a regular basis. - Report spills to the office immediately, even if they are being controlled.	-N/A
Additional Observations

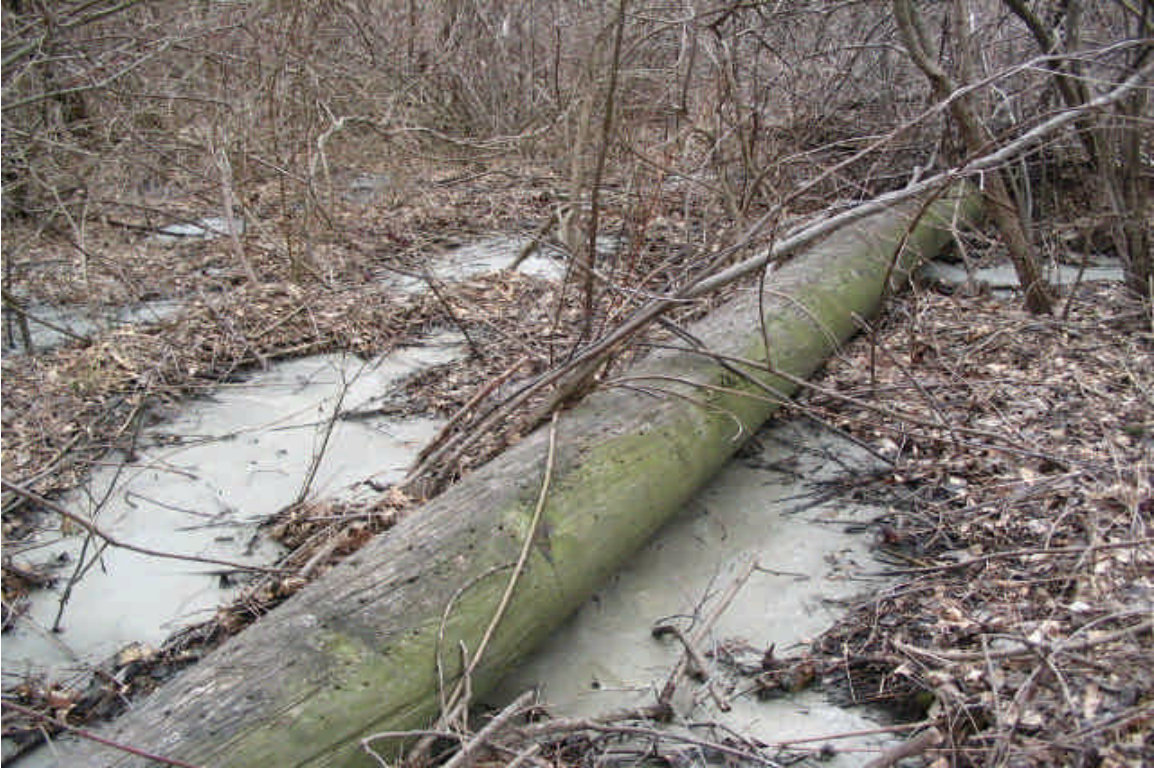
Inland Wetland and Watercourse encroachment and mitigation	<p>- Wetlands are located around the outskirts of the substation yard.</p> <p>- The sediment tracked into the wetlands and settled in several locations. 3/24/06.</p>	- Crews will have to remove the sediment carefully from the wetlands ASAP. 3/24/06.	
State species of concern, threatened and endangered species	- Although there was no evidence of a nest in the previous stockpile, crews returning to the site at this time will have to remain aware of the fact the weather is warming and the wood turtle could return to the site in the spring. 3/15-3/24/06	- Move machinery carefully and perform daily walkdowns of the site each morning when the weather gets warmer. 3/15-3/24/06.	- N/A until the weather warms up.
Vegetative clearing limits (including trees to save or danger trees noted)	- No vegetation outside of the substation yard will need to be cleared during the expansion work.	- N/A	- N/A

The drill cuttings seeped into the wetland from the yard and collected in some of the low spots.
3/24/06

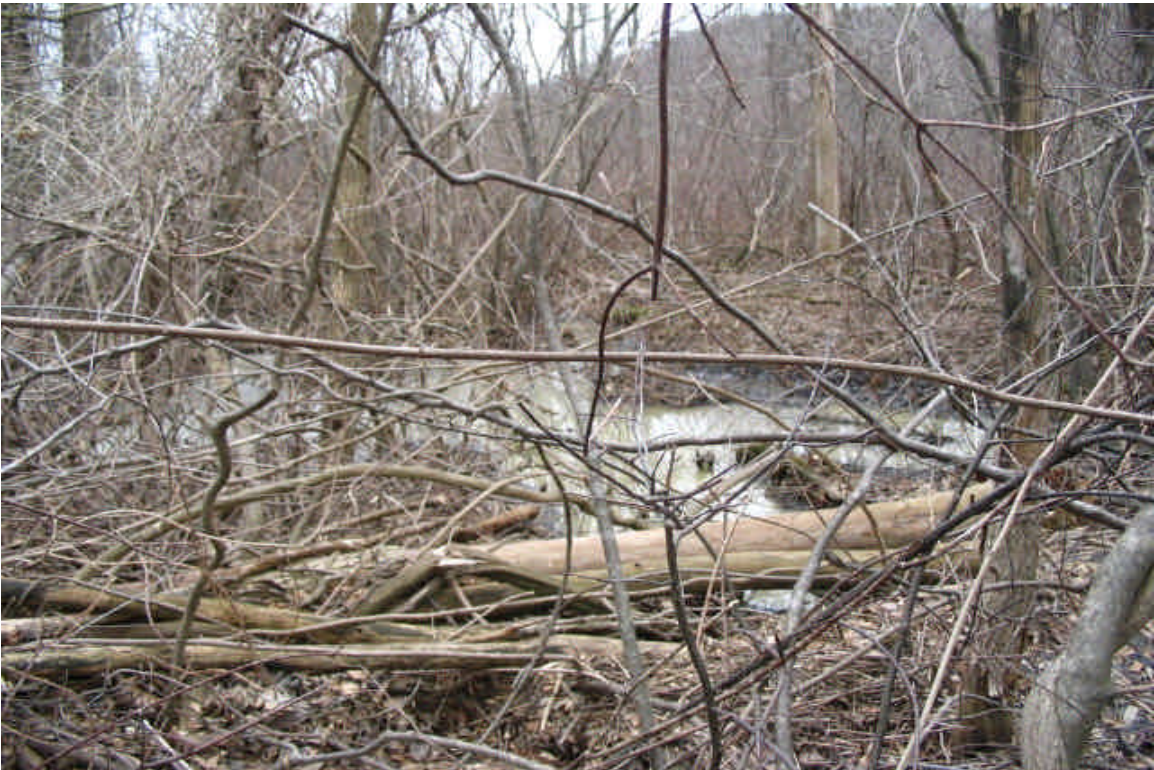
Another view of the sediment within some of the standing water in the wetlands. Crews are going to have to remove this to the best of their ability as carefully and as soon as possible. 3/24/06
